**ASES 52nd Annual National Solar Conference 2023
(SOLAR 2023)**

Investigation of crystalline silicon photovoltaic modules degradation after 14 years outdoor exposure in Cologne climate (Germany) by electroluminescence (EL) and infrared (IR)

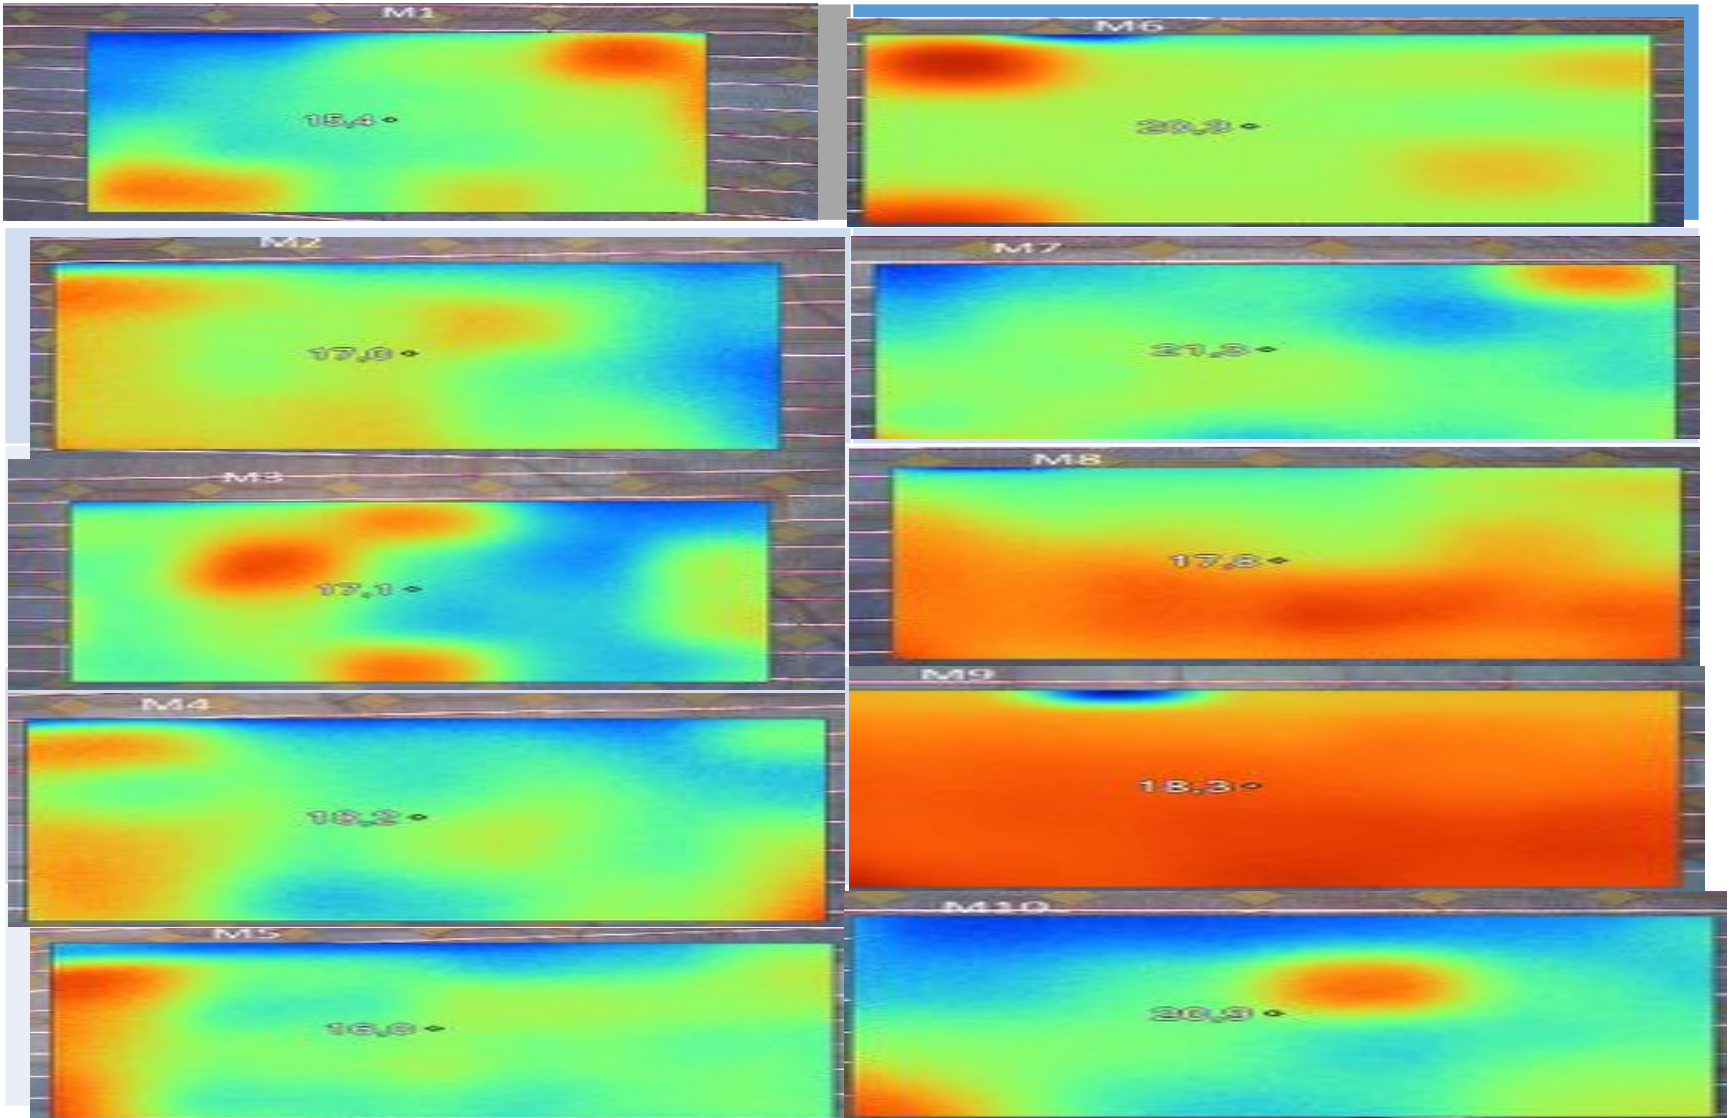
Fig.2. thermography of the ten multicrystalline PV module

The thermography imaging shows that, the modules do not have homogeneously the same temperature on the front side. Hot spots are found on the module M6; M7 and M9. (see fig. 2).

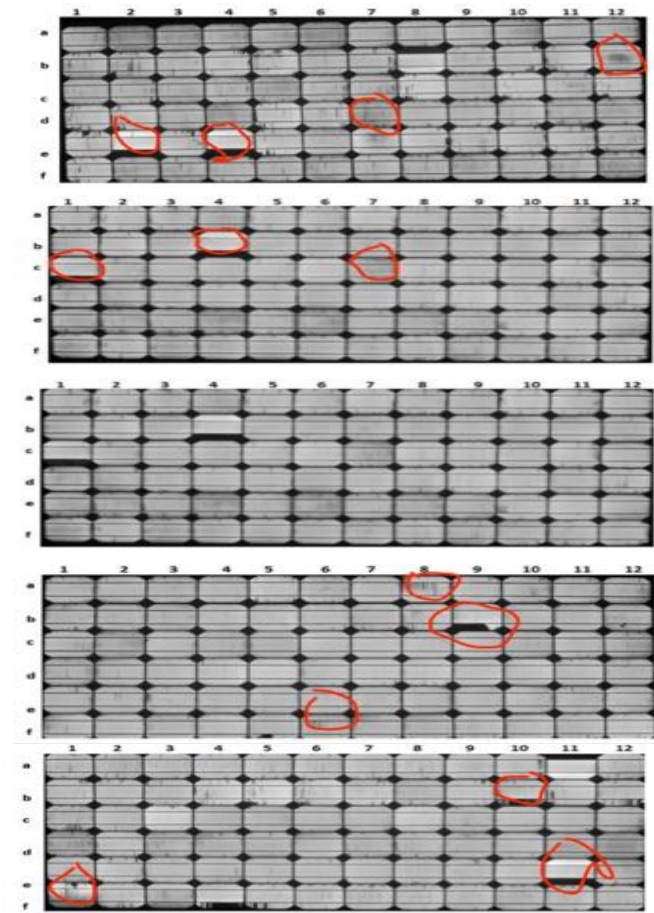
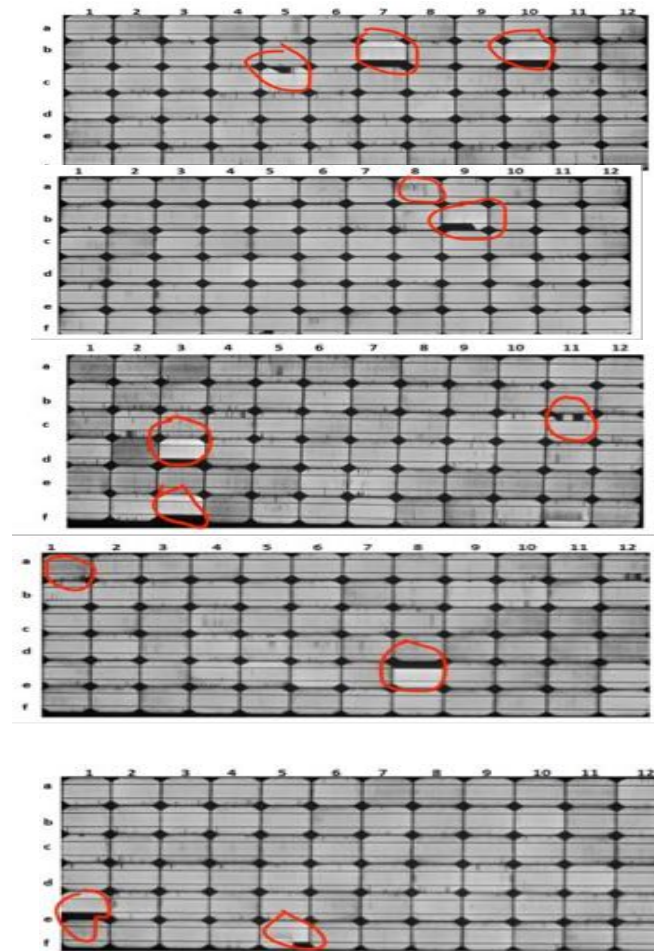
Fig 2: Different categories of defects found in different modules investigated

Name	Module		Module/cell
Finger interruptions	M8

M8 (1b)
Degradation of cell interconnection	M6

M6(2d)
Humidity corrosion in low damaged solar cell	M1 ; M2 ; M6

M1 (2f) ; M2 (8b) ; M6 (3f)
Striation ring	M2

M2 (12b)
Dendritic crack	N4

M4 (5e)
-45° crack	M1 ; M3 ; M7 ; M9

M1 (10b) ; M3 (9a) ; M7 (3e, 7e and 12e) ; M9 (3e and 12e)
+45° crack	M1; M7 ; M9

M1 (2e) ; M7 (7e) M9 (7e)

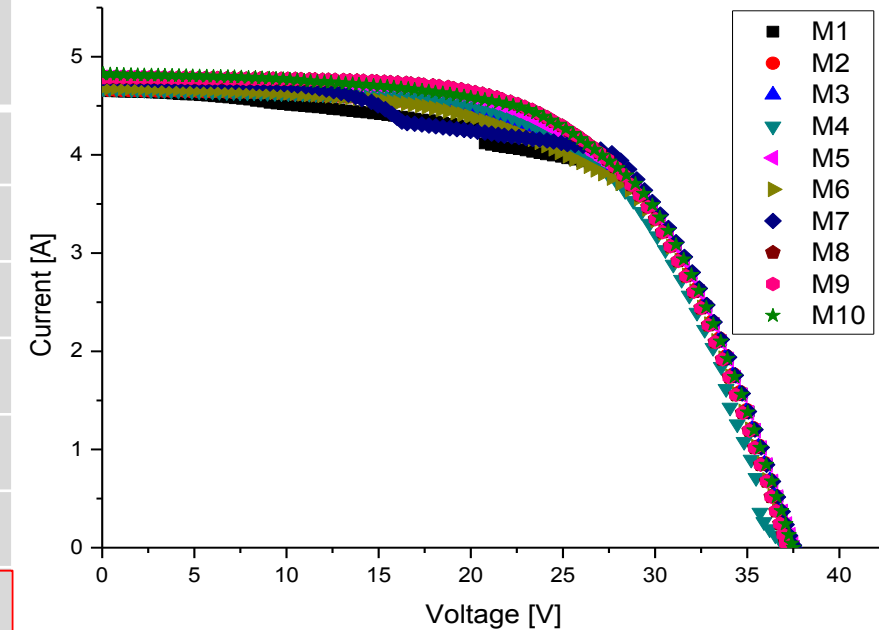
Fig.6. I-V Characteristic of the modules after 14 years

- ❑ This work proposes a characterization of crystalline PV modules after 14 years in outdoor exposure at Cologne (Germany).
- ❑ The principal method is Electroluminescence (EL), infrared imaging (IR), I-V and P-V characteristics.
- ❑ Results show that the maximum power degradation rate and the maximum short circuit-current degradation rate are 2,21% per year and 0,46% per year, respectively
